# **Condition Assessment of William Beaumont General Hospital Historic Buildings at Fort Bliss, Texas**

Thomas R. Napier and Sheila A. McCarthy

September 2002

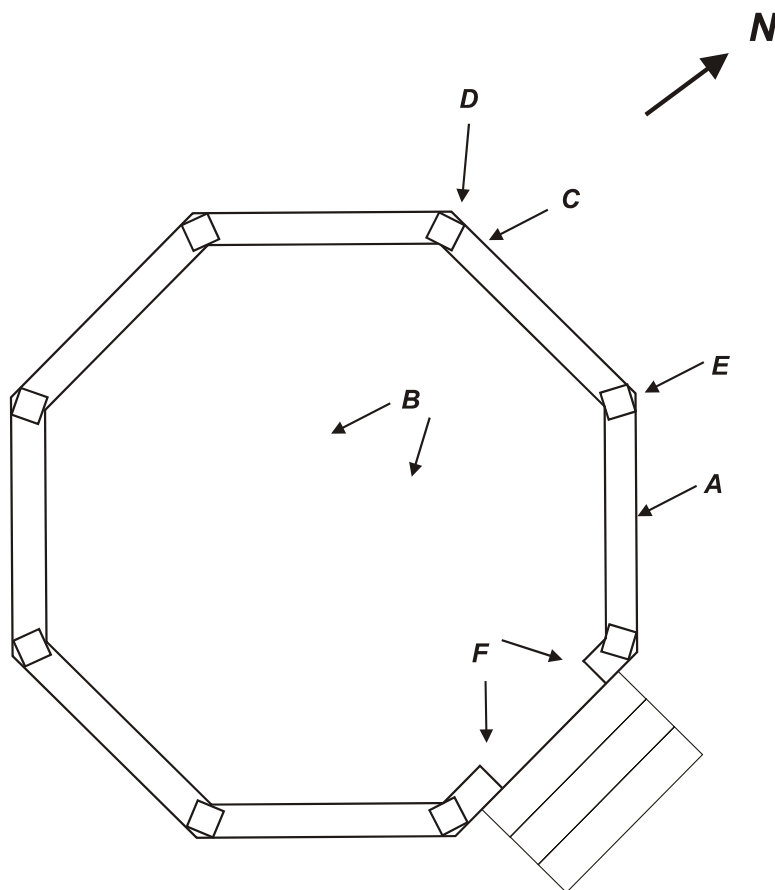
Drawing 1. Building 7122 key plan.

The floor slab is cracked in the slab's interior (Drawing 1, B). Although the cracking is significant, no differential settlement or displacement of slab sections is evident. Furthermore, the floor slab is seriously cracked at the corners. Some concrete has fallen away, with the northwest corner being the most seriously damaged. In addition, reinforcing is visible. There is also a pipe embedded in the slab, presumably for floor drainage, that discharges runoff at the slab's corners. Roughly 1 in. of concrete covering this pipe has spalled away (Drawing 1, C; Photograph 2). The bottom edges of the slab are also spalling at places around the perimeter. Repairing this slab may be possible, although replacing it may be more practical. Sloping the slab toward the perimeter and eliminating the embedded drains should provide a simpler and more durable solution.

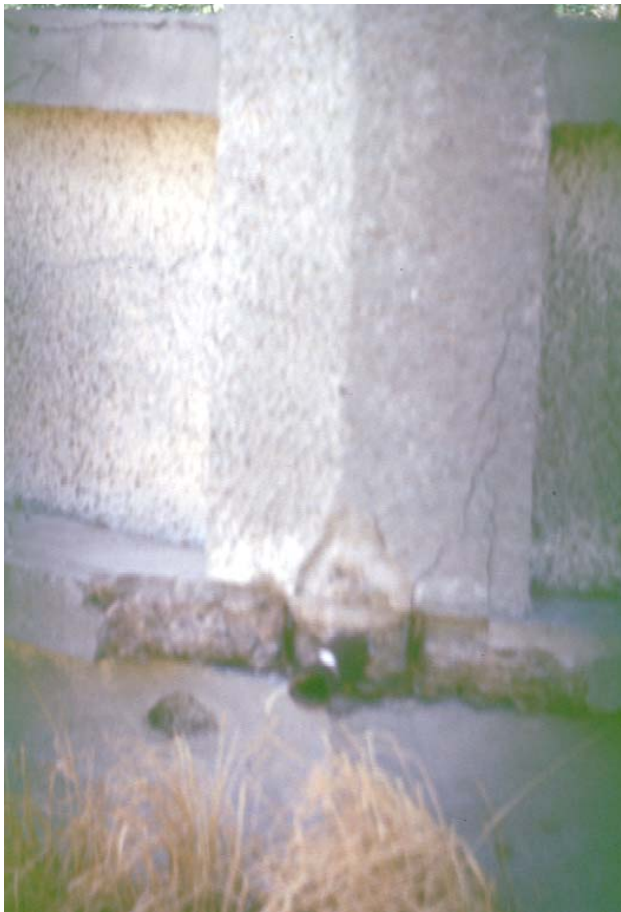
**Photograph 2. Detail of spalled concrete on bandstand.**

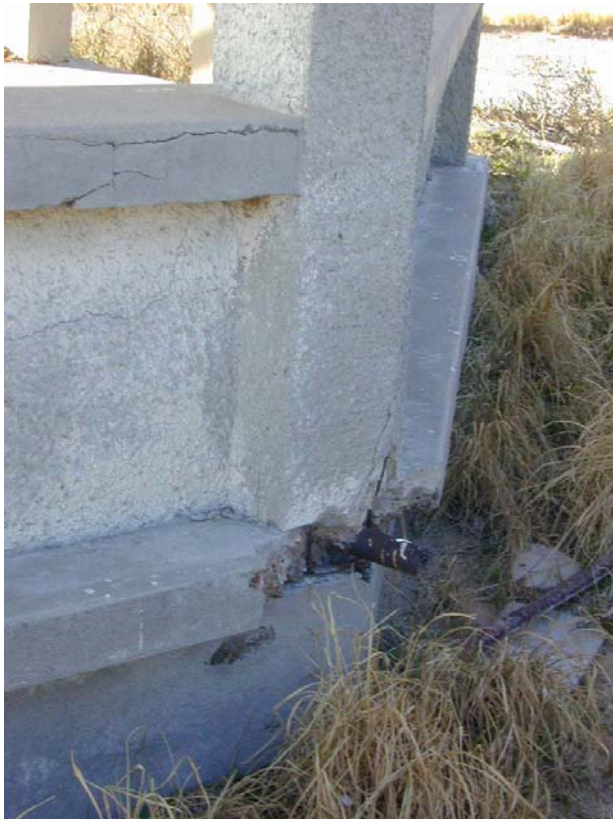
One column is cracking at the base (Drawing 1, D). The northeast side column is badly spalled and the reinforcing is exposed (Drawing 1, E; Photograph 3). Concrete spalling and cracking will have to be repaired.

**Photograph 3. Detail of exposed concrete reinforcement on bandstand.**

If the concrete surface is sealed from water intrusion, repairs to the columns and rails should remain effective upon rehabilitation.

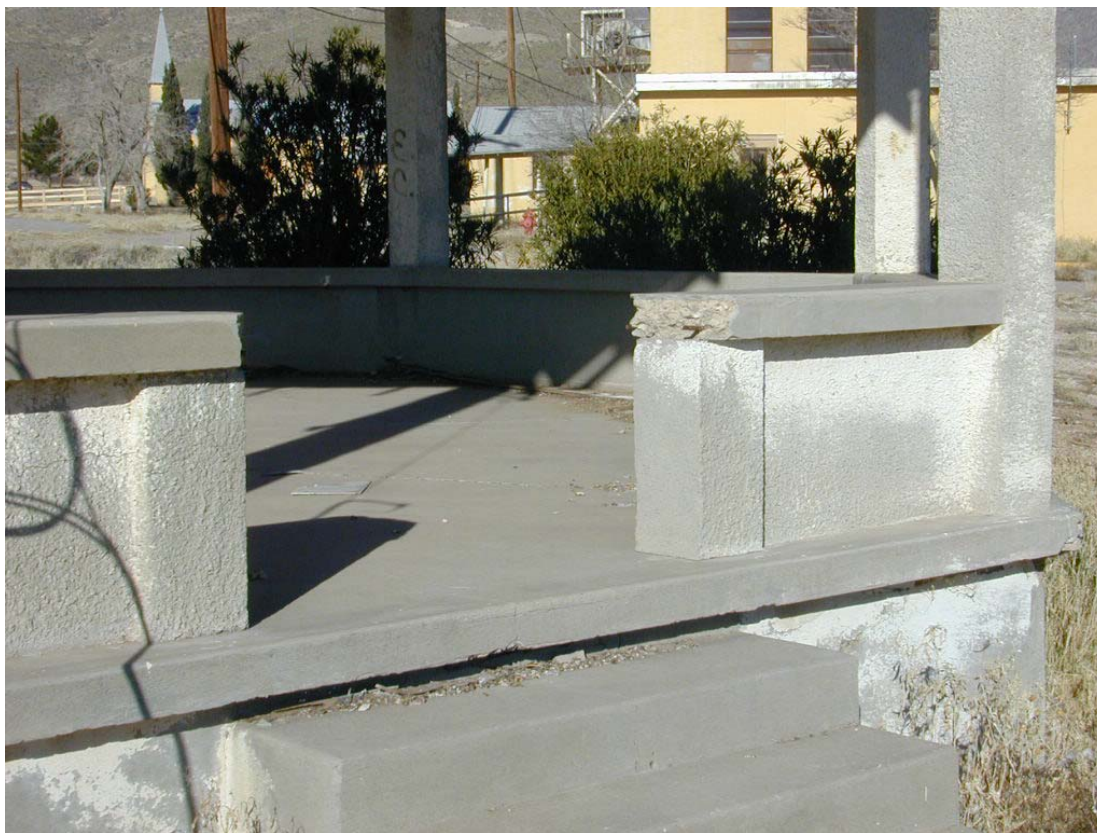
The entrance at the southeast side of the bandstand has apparently been enlarged by chopping away at the concrete rail. The edges are rough-cut (Drawing 1, F) and will need to be either ground smooth or patched to remove a hazard and improve appearance (Photograph 4).

**Photograph 4. Detail of bandstand entrance.**

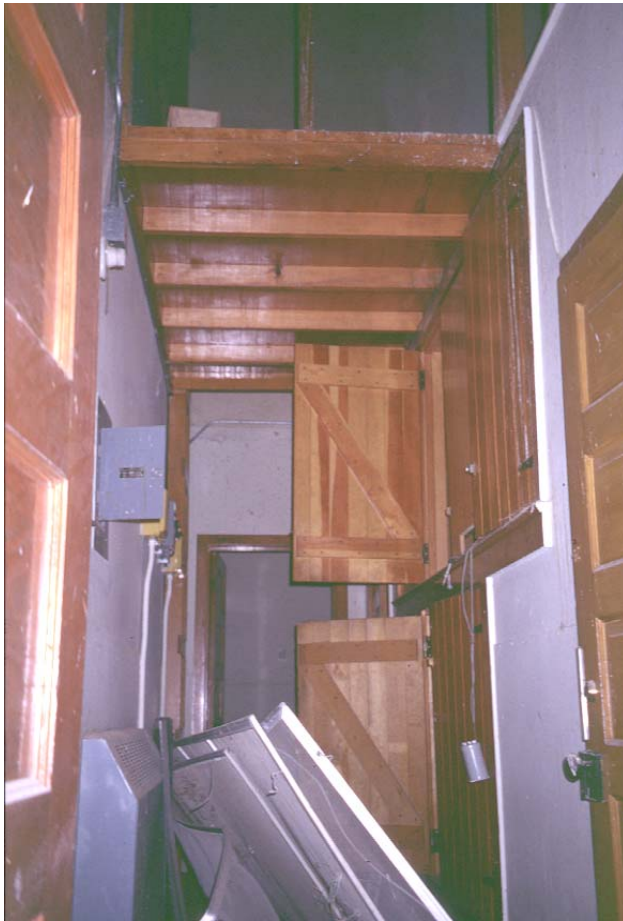
The cabinetry at the back of the sanctuary area remains largely intact, although other materials have been strewn in this area (Drawing 2, Q; Photograph 13). The doors are still in place and operable. This cabinetry should be serviceable with refinishing. Alternatively, it can be removed if it is unsuitable for future occupancy.

**Photograph 13. Detail of chapel cabinetry.**

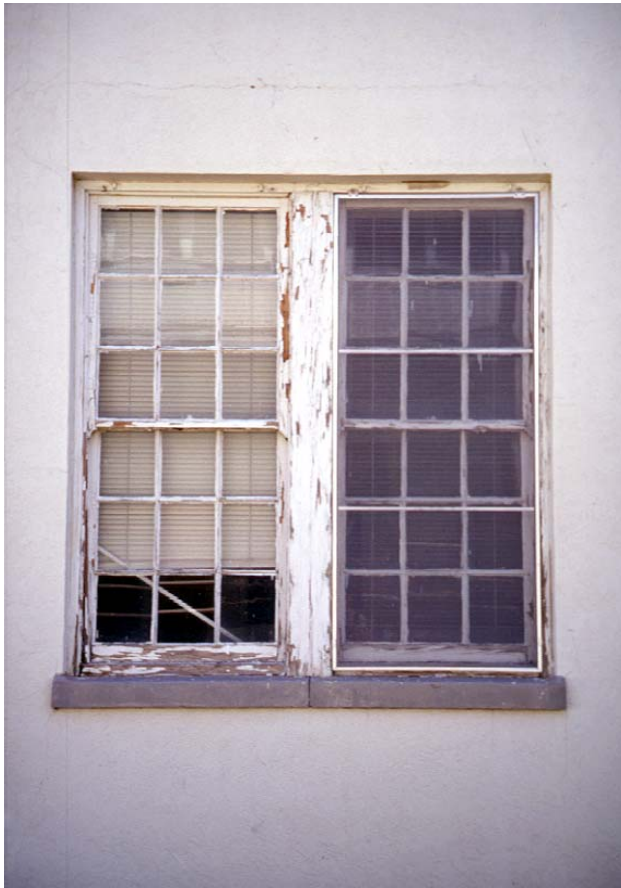
The most serious damage occurs on the west walls where several windows in each building will require some extensive repair (Photograph 42). For instance, most mullions dividing the first floor double windows are split at the bottoms. In addition, several mullions are deteriorated to the point that some original components may have to be replaced rather than repaired. Several bottom sash rails are seriously deteriorated. Second floor windows on the east side generally have suffered less deterioration.

**Photograph 42. Seriously deteriorated barracks windows.**

The windows remain generally intact and operable, although their condition varies considerably. As part of an exterior restoration, minor repairs, replacement of glazing compound, scraping, priming, and painting will be required as a minimum.

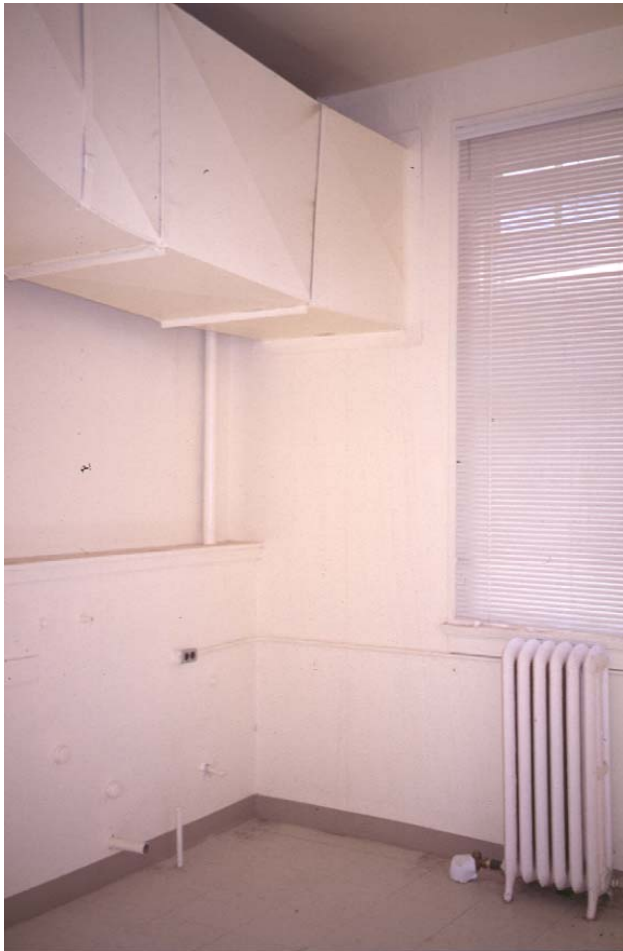
The first floor is serviced by an evaporative cooler located at grade level outside of room 105. A duct enters the room through one window's upper sash, which tees into the supply duct running the length of the building and supplying each room. The second floor is serviced by a cooler mounted on a steel-framed tower at the south end of the building outside of room 202. A duct enters the room through the wall and runs the length of the building, supplying each room. The coolers were installed 5 years ago and are reported by DPW personnel to be serviceable (Photograph 50).

Photograph 50. Building 7157 cooling equipment.

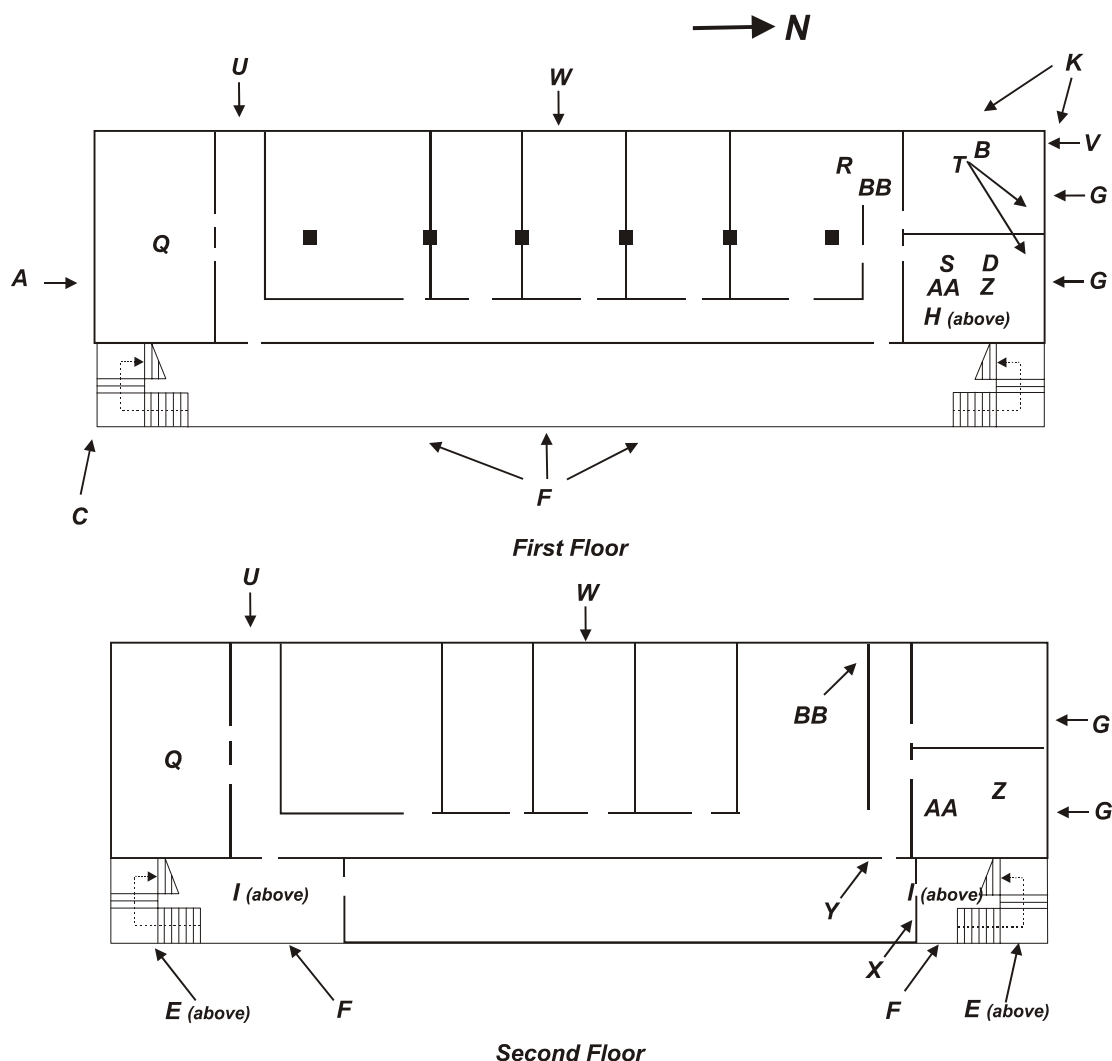
**Drawing 6. Building 7158 key plan.**

The partitions dividing the two NCO rooms at the south end of the building have been removed at both the first and second floors (Drawing 6, Q). The floor slopes slightly toward the center of the building at the first floor, where the partition was located. However, no excessive deflection or sponginess in the floor was observed at this location.

Similar to Building 7157, there is a low spot in the first floor, in the northwest corner of room 106 (Drawing 6, R). Leakage and water damage is apparent by the buckling in the underlayment. While no other sponginess, deflection, or distress was evident, evaluating the floor framing and subfloor at this location is recommended as part of a reuse design. Several joists had been notched at the bottom (tension) edge for an electrical conduit in the same location in Building 7159. It is possible a similar modification may have also been made in Building 7157 and 7158 as well.

A crack has opened at the northwest corner of Rooms 106 and 206 (Drawing 6, BB). It is apparent that the floor settlement is pulling the partition away from the exterior wall. Once the floor deflection is stabilized, this crack should be repaired as part of the interior's rehabilitation and should remain effective.

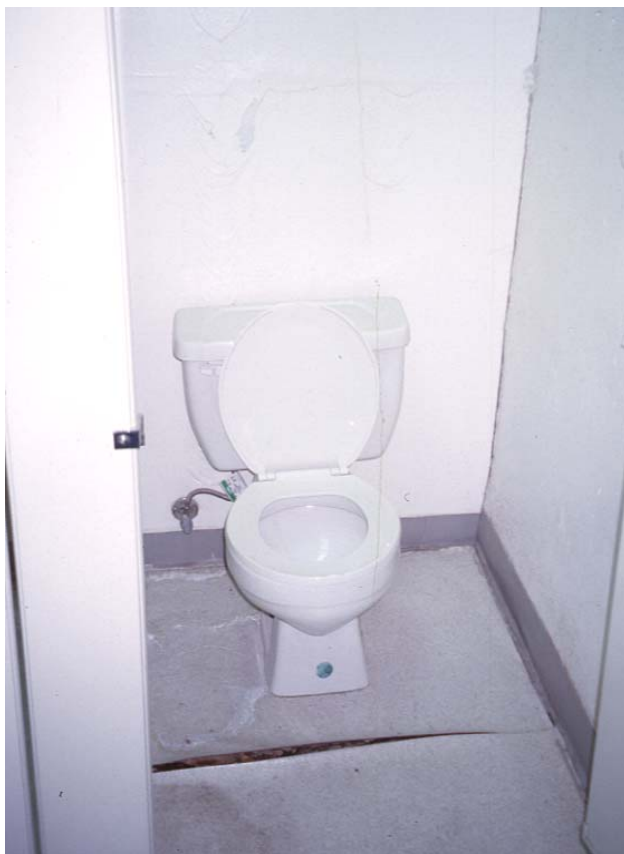
Water leakage and overflow has damaged the plaster in the washroom partitions on both the first and second floors (Drawing 6, Z; Photograph 52). Water leakage has also damaged the vinyl flooring to the extent it is peeling off of the floor (Drawing 6, AA; Photograph 53). These items will require extensive repair.

**Photograph 53. Damaged vinyl flooring in Building 7158 washrooms.**

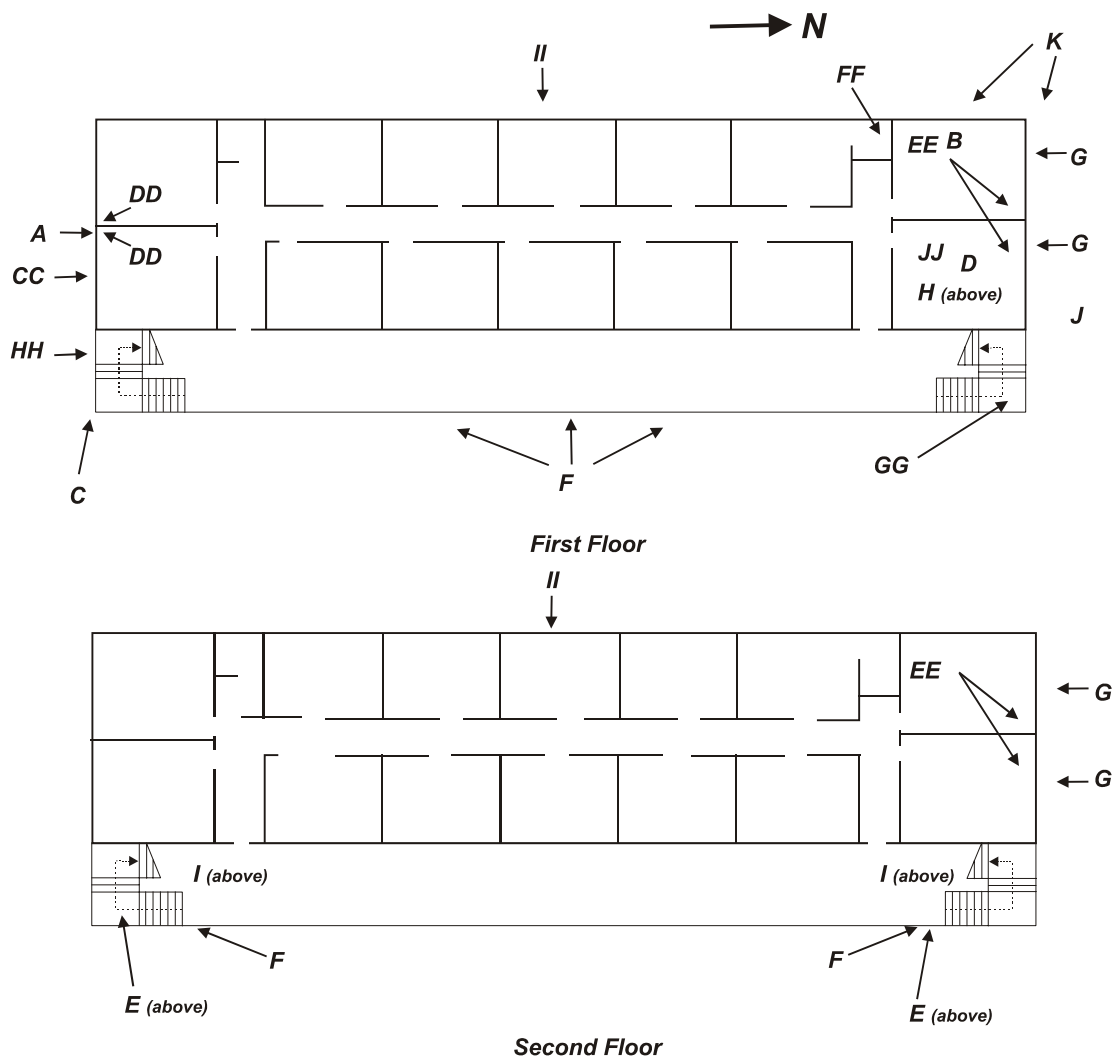
Drawing 7. Building 7159 key plan.

The south foundation wall is cracked through its thickness at the crawl space access (Drawing 7, CC; Photograph 54). However, the horizontal marks made by form boards during construction are still aligned, indicating that no differential settlement has occurred at this crack. It is, therefore, presumed to be stable.

An observation is made about the porch framing. At the north stairwell, the connection of the easternmost beam (exterior, supporting the second floor joists at the outboard ends) and column at the northeast corner is questioned (Drawing 7, GG). A space exists between the beam's end and the load-bearing member of the column assembly. This space is wide enough to insert one's hand. The end of the beam could be felt (Photograph 57). There appeared to be no haunch or bracket supporting this beam, suggesting it may be supported only by the column's enclosure. Again, without removing the enclosure, this conclusion is somewhat speculative. DOE personnel recently observed the demolition of a building with a similar porch,

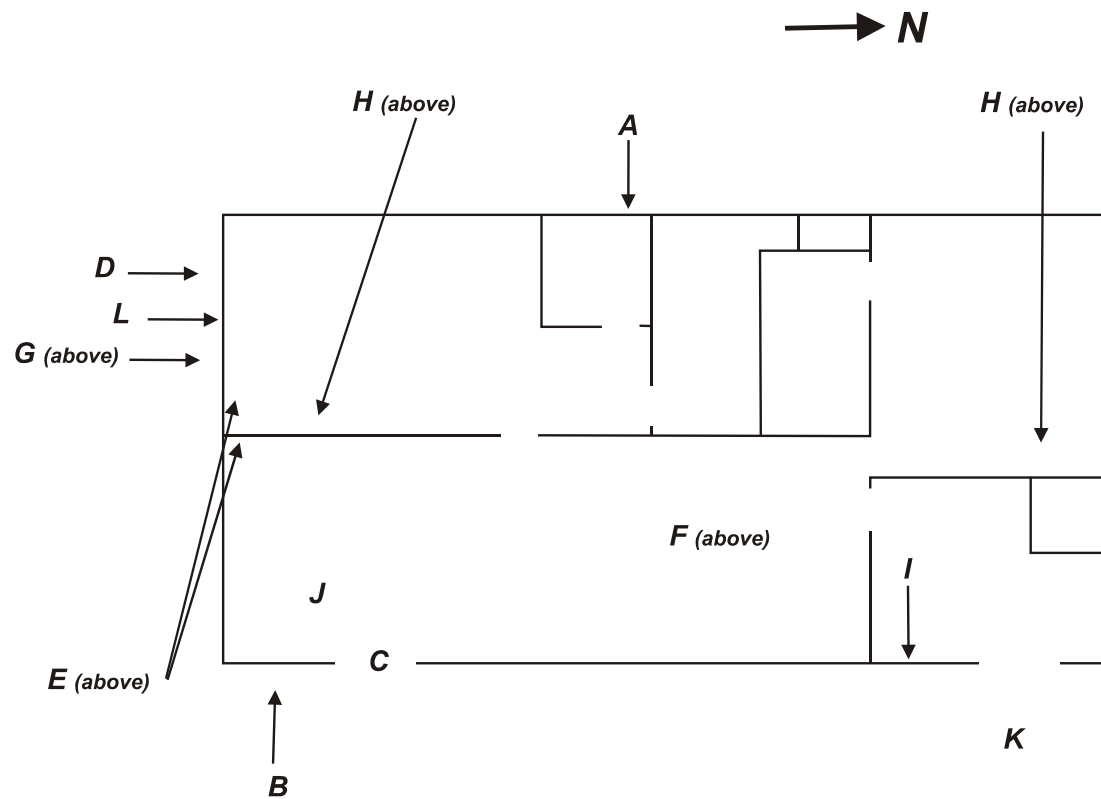
Drawing 8. Building 7166 key plan.

A vertical crack occurs in the parging on the east side of the foundation, where an addition was constructed (Drawing 8,A; Photograph 61). The crack continues up

An exterior slab is present at the north end of the west side of the building, adjacent to an entry (Drawing 8, K). Parking is immediately west of the slab at this entry (Photograph 68). The west entries' thresholds are at grade, which are below the grade and paving to the west. Rainwater runoff flows down Beaumont Drive, over the paving, collects against the building, and leaks into the building through the wall and under the door. Water intrusion under the west entry doors and through

The south portion of the basement should be accessible through a basement level door at the south side of the building (Drawing 8,L; Photograph 69). However, this entry was blocked by sedimentation, apparently deposited by runoff collecting against the south side of the foundation.

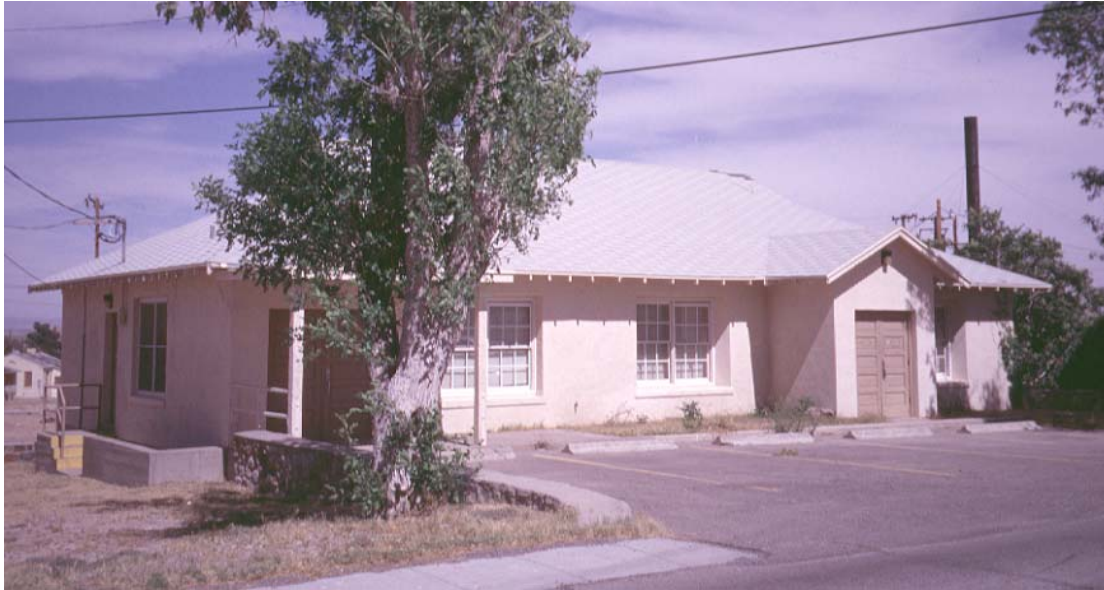
**Photograph 68. Exterior slab and parking area at BOQ.**

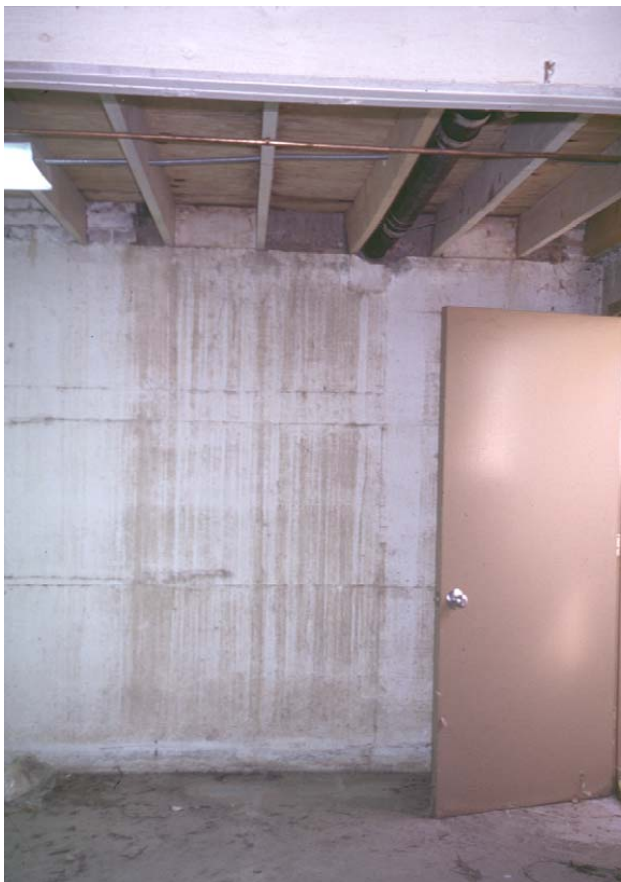
**Photograph 69. Water damage on BOQ basement wall from runoff.**

the adjacent wall is evident on the interior finishes. Leakage over the top of the foundation in the northwest corner of the building is evident by the streaking visible on the west basement wall (Photograph 69).

- Redevelop the site's drainage at the west and south sides of the building to ensure positive drainage away from the building.
- Repair missing shingles. Consider increasing the slope of the porch at the north door on the west wall and installing metal roofing more consistent with the porch roofing depicted on original designs of surrounding buildings.
- Replace the south basement door with a historically appropriate style.
- Examine the evaporative cooler for leakage; repair as appropriate.
- Perform exterior repairs and repaint walls and trim.
- Examine the floor framing adjacent to the main (west) entry. Repair the sub-floor and/or underlayment as required.
- Thoroughly clean the carpet, or replace if necessary.
- Perform routine interior repairs and repaint walls and ceilings.

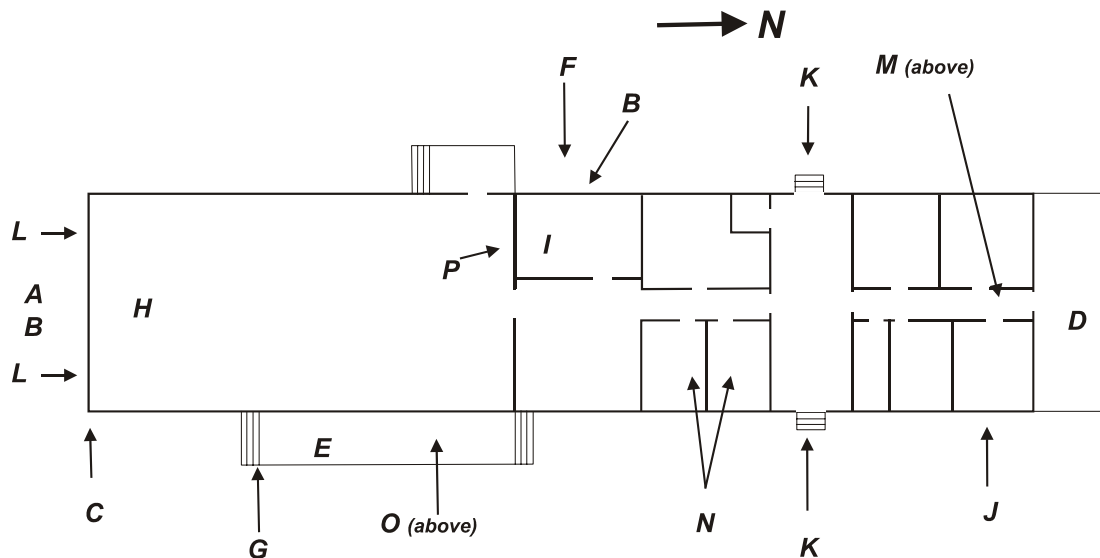
Drawing 9. Building 7167 key plan.

Parging is peeling off of the concrete at the south wall (Drawing 9, A). There are several minor cracks in the foundation. For example, there are some minor cracks that occur at the crawl space vents on the east and south walls (Drawing 9, B). One noticeable crack occurs at the southwest corner of the building (Drawing 9, C; Photograph 71). This crack has been patched in the past, but has since broken

open. The crack continues through the foundation wall, as daylight can be observed from the crawl space. The reinforcing may not be continuous all the way around the corner, allowing the south and west walls to move apart. A hairline crack in the wall appears above this crack; however, no differential settlement or distortion is evident in the foundation at this location. If the crack did not propagate into the wall, it would be of little concern and sealing it would be an appropriate repair; yet, the south foundation wall may be moving slightly outward at that corner. The south foundation wall may require anchoring to the west foundation wall to arrest further movement.

The porch slab on the north side of the building is cracked in a north-south direction (Drawing 9, D; Photograph 72). The slab on the west porch is also cracked (Drawing 9, E; Photograph 73). The wheelchair access ramp on the east side of the building is also cracked and is falling away from the building (Drawing 9, F).

The stairs at the west porch are badly cracked, especially the south stairs (Drawing 9, G; Photograph 74). The exterior retaining wall appears to be falling away from the building, and opening a crack between the wall and the stairs.

These cracks appear to be caused by uneven settlement of the slabs, possibly because of insufficient compaction in the fill below them. While it may be possible to repair these concrete structures, it may be more practical to rebuild them.

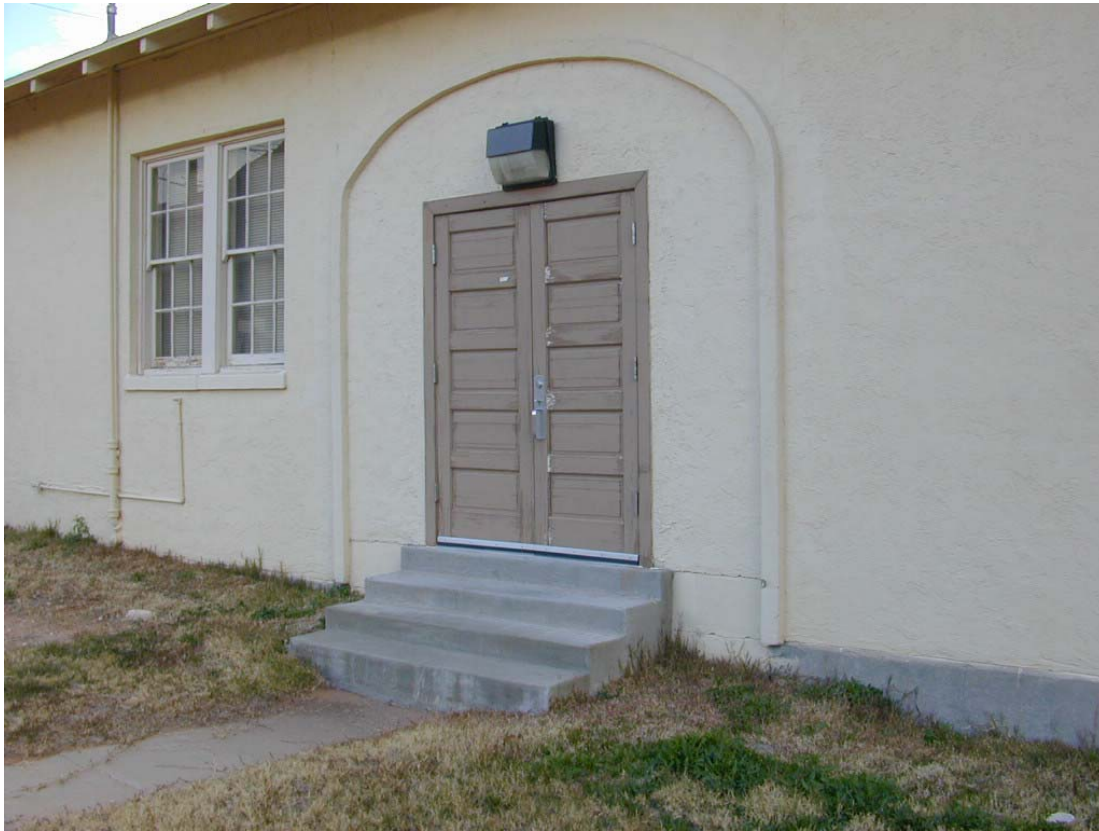
**Photograph 79. Original arch opening in Conference Center.**

An open arch, called a “porch” on the original drawings, once ran laterally through the north end of the building. The arch ends in the east and west walls have since been filled, and the “porch” converted to an interior space. The outline of the original arch opening, however, has been incorporated into the infill design (Drawing 9, K; Photograph 79).
